NOMINATION FORM
for the
NATIONAL REGISTER OF HISTORIC PLACES, NATIONAL PARKS SERVICE

Wesley M.E. Church

D- 271

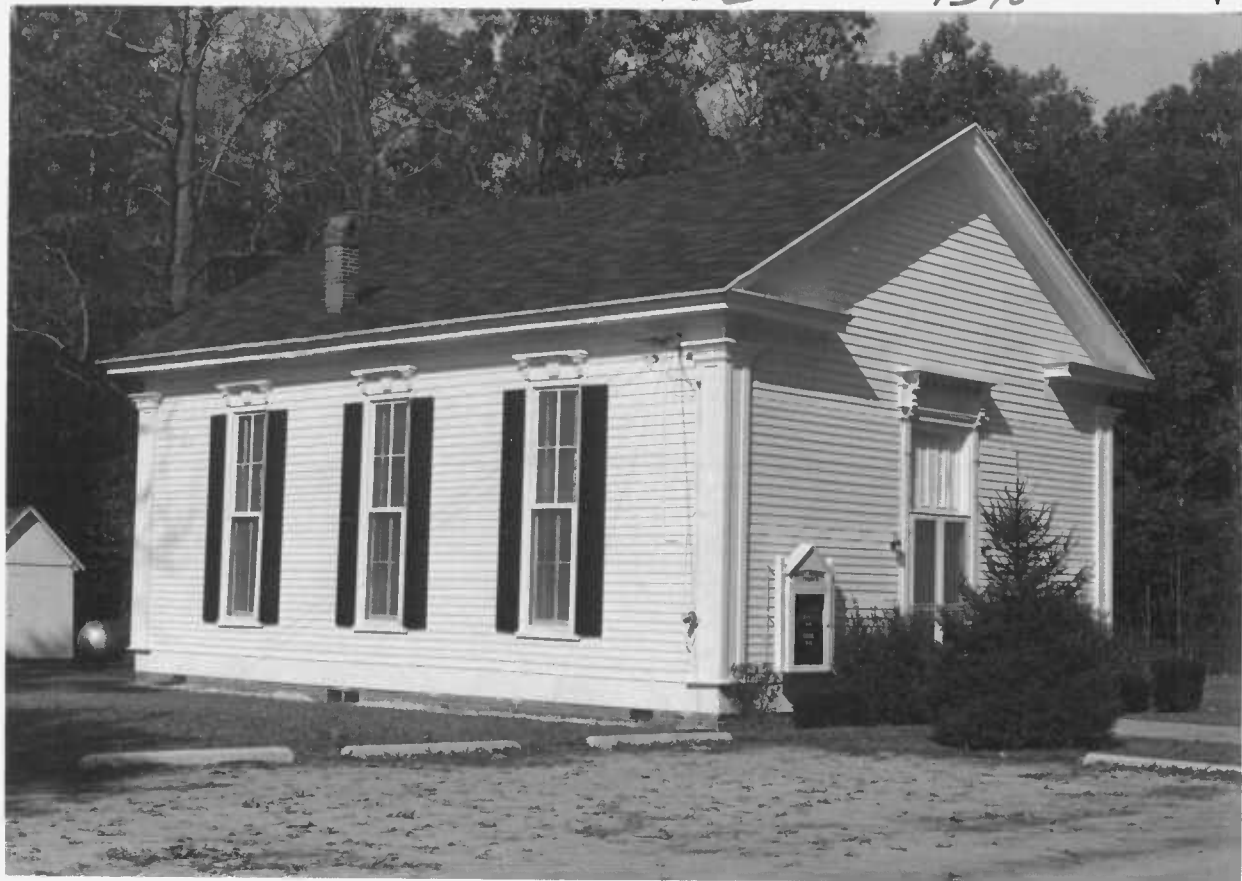
| 7. DESCRIPTION | |
|--|---|
| <p>This church is typical of the mid-19th century. Like most of the small Dorchester and Caroline County structures, this building has a central gable entrance. Its double doors have panels above, matching the panels on the doors, and an even higher architrave. On the corners of the building are recessed paneled pilasters, the capitals of which end before they reach the overhanging eave. The building is constructed on a brick foundation, which is 20th century in date. The base of the structure is covered with plywood, although, there obviously was a very wide lower board. The walls are covered with weatherboard approximately 5 inch exposure.</p> <p>The church is three bays deep with 4/4 sash and louvered shutters. At the top of each of the windows is a rather simple decorative cornice. In the west gable is a very small projection from the sanctuary, which also has corner pilasters. It is a much lower portion and has a single 4/4 sash and an "A" roof.</p> <p>The building has an "A" roof. Between the second and third bays, on each side, is a brick chimney that issues from the roof. In the north east corner is a date plaque with the words: Wesley M. E. Church, a.d. 1874.</p> | |
